REPORT NUMBER: 201U-CAL-05-04

**SAFETY COMPLIANCE TESTING FOR FMVSS 201
OCCUPANT PROTECTION IN INTERIOR IMPACT
UPPER INTERIOR HEAD IMPACT PROTECTION**

**GENERAL MOTORS OF CANADA LTD.
2005 BUICK LACROSSE 4-DOOR SEDAN**

NHTSA NUMBER: C50104

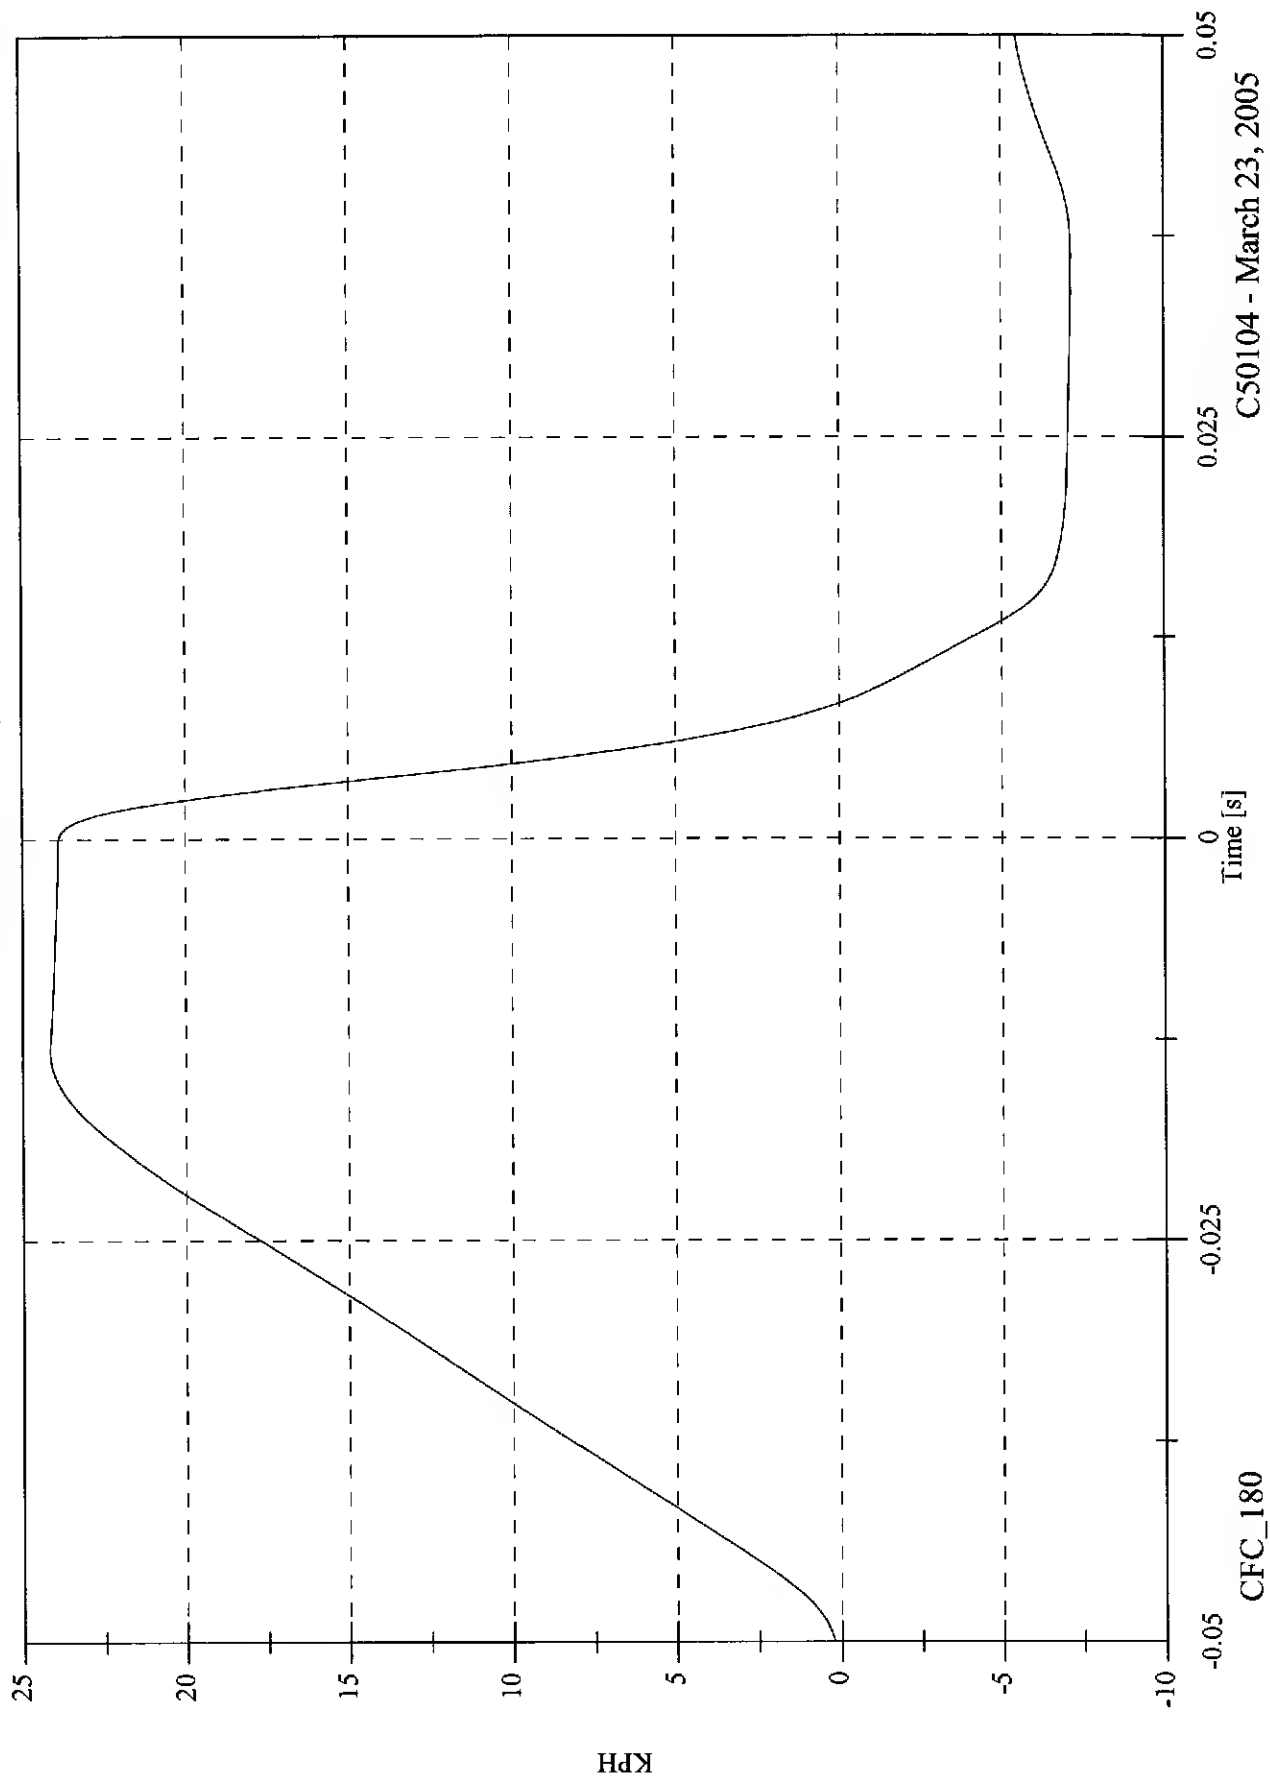
FMVSS 201U IMPACT TEST - 2005 Buick Lacrosse Sedan
Headform Velocity
Max: 24.2 [KPH] at -0.013 [s]
Min: -7.2 [KPH] at 0.036 [s]

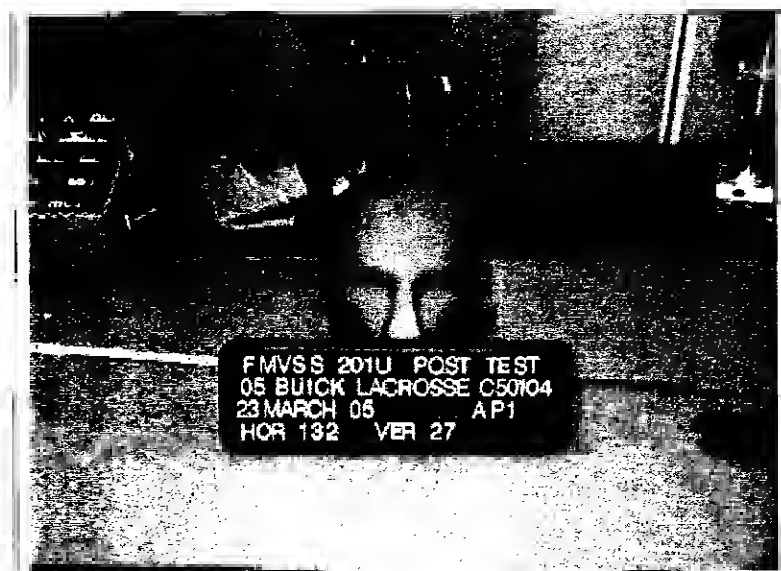
POST-IMPACT AP1 HEADFORM

Free Motion HIC	641.7
HIC(d)	650.5
Impact Velocity (kph)	23.46
HIC T1 (msec)	2.3
HIC T2 (msec)	7.7

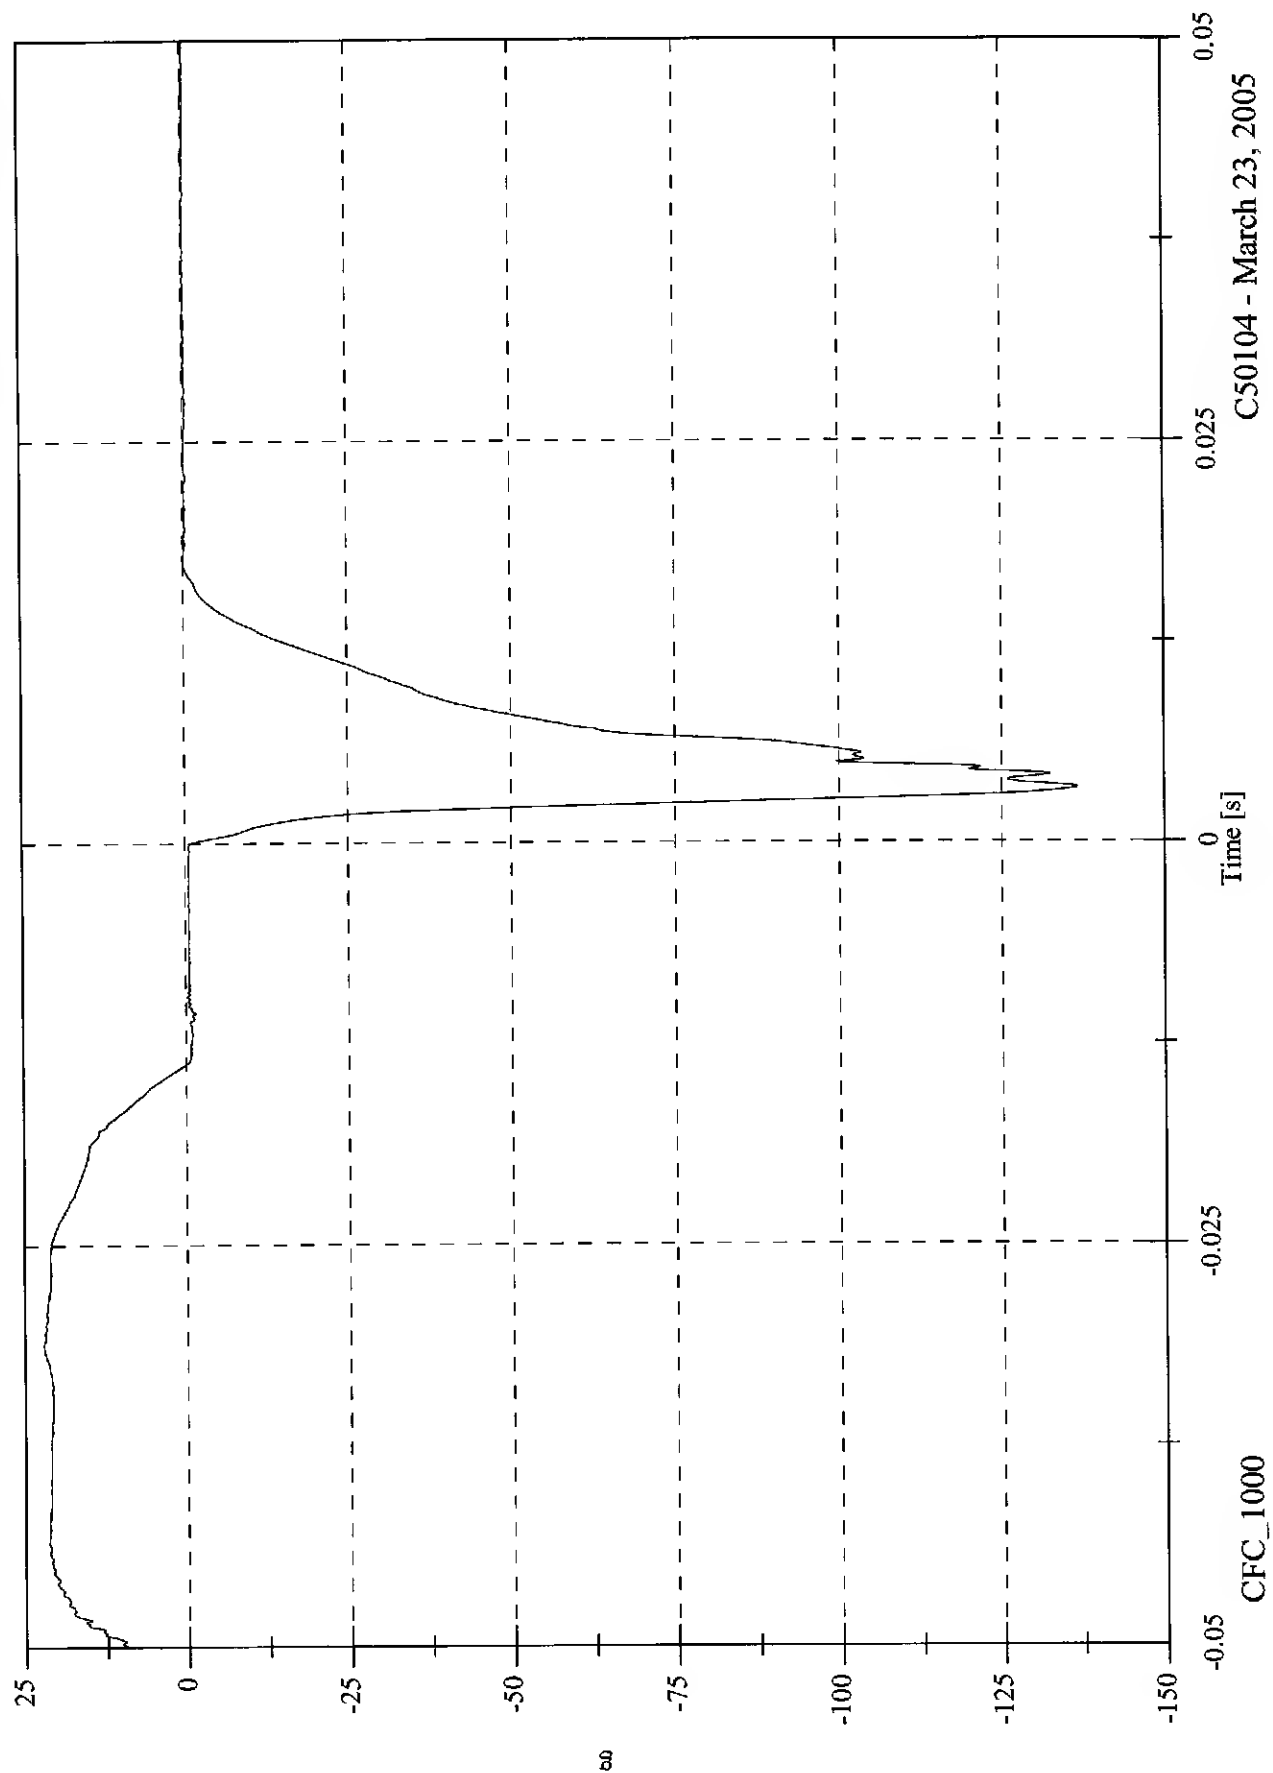
FMVSS 201U IMPACT TEST - 2005 Buick Lacrosse
Headform X Acceleration

Max: 22.1 [g] at -0.031 [s]
Min: -136.8 [g] at 0.003 [s]

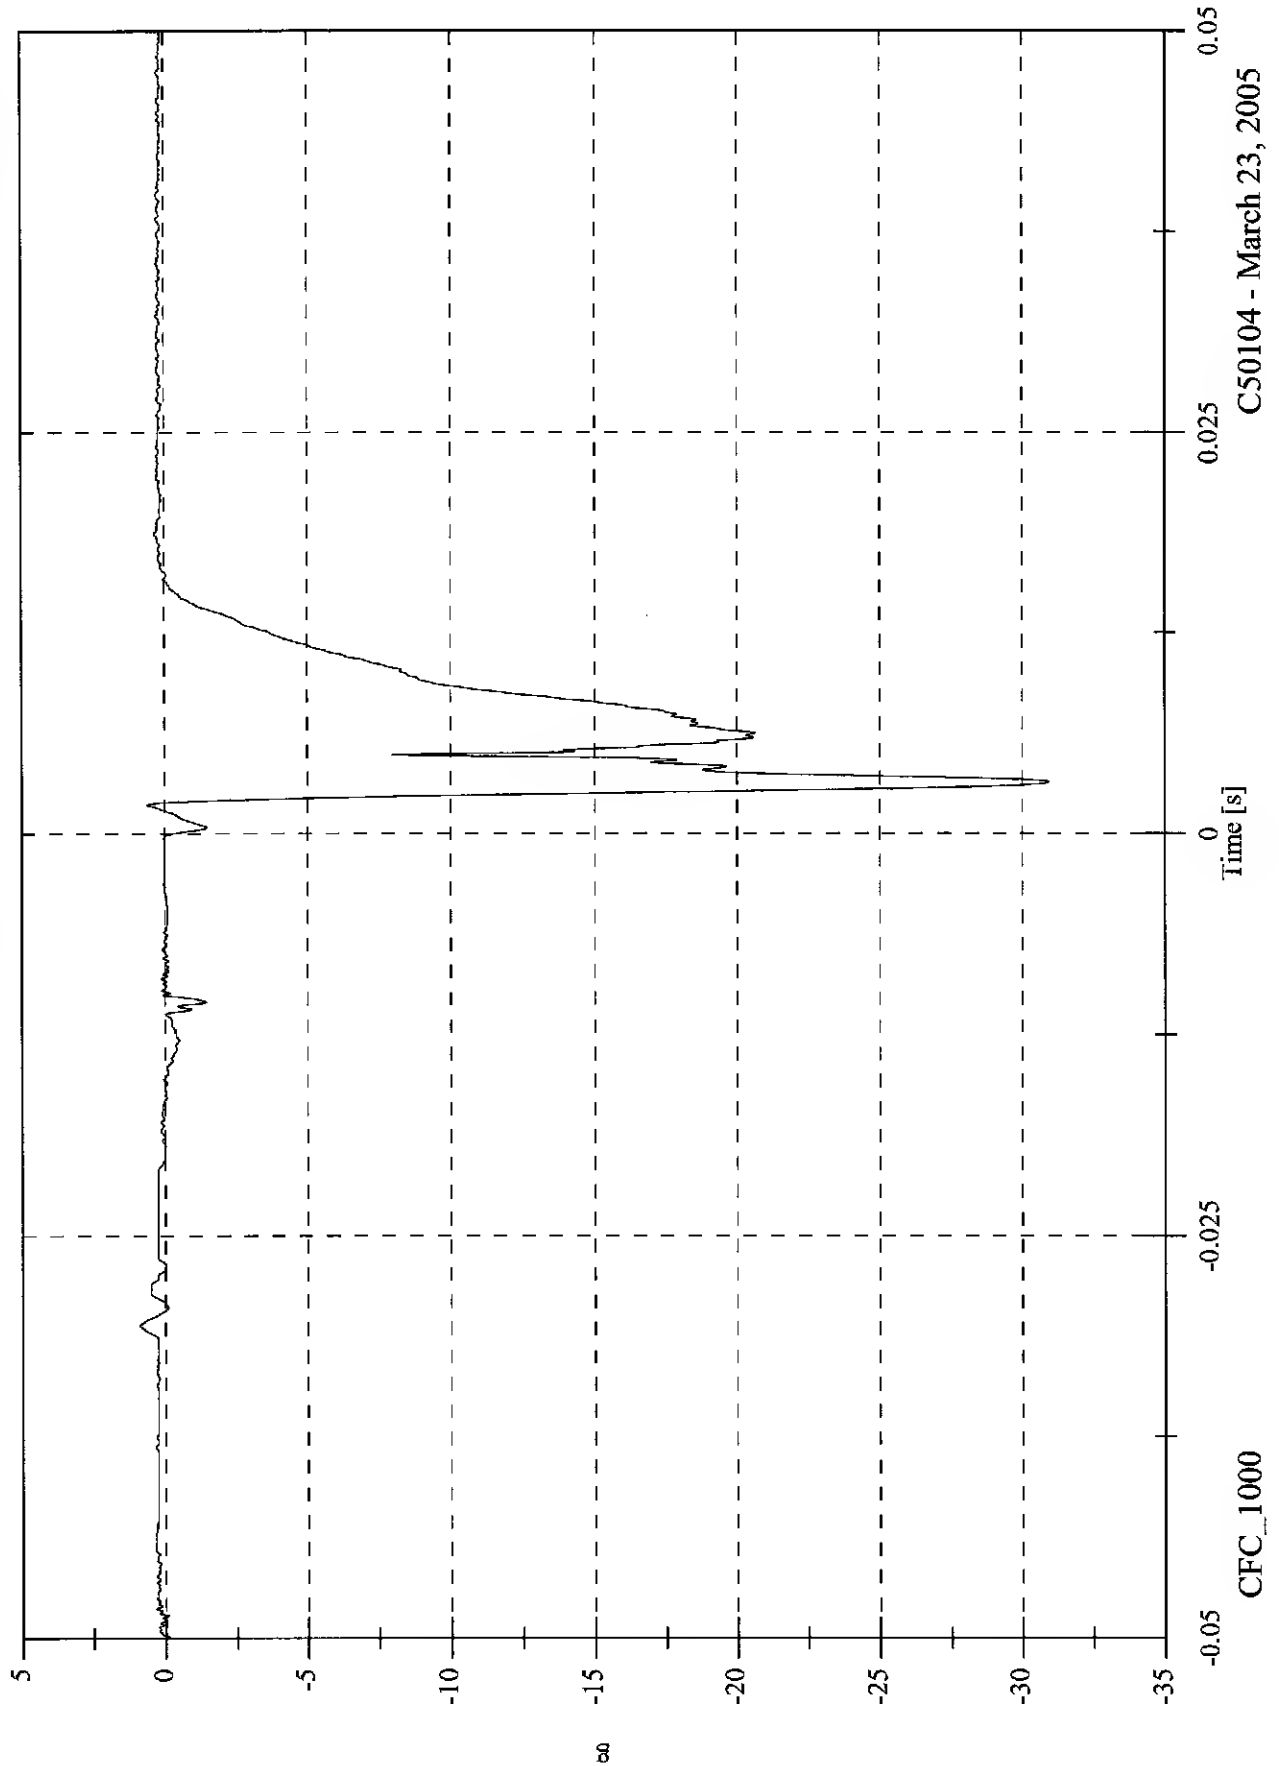
FMVSS 201U IMPACT TEST - 2005 Buick Lacrosse

Headform Y Acceleration

Max: 0.9 [g] at -0.031 [s]
Min: -30.9 [g] at 0.003 [s]

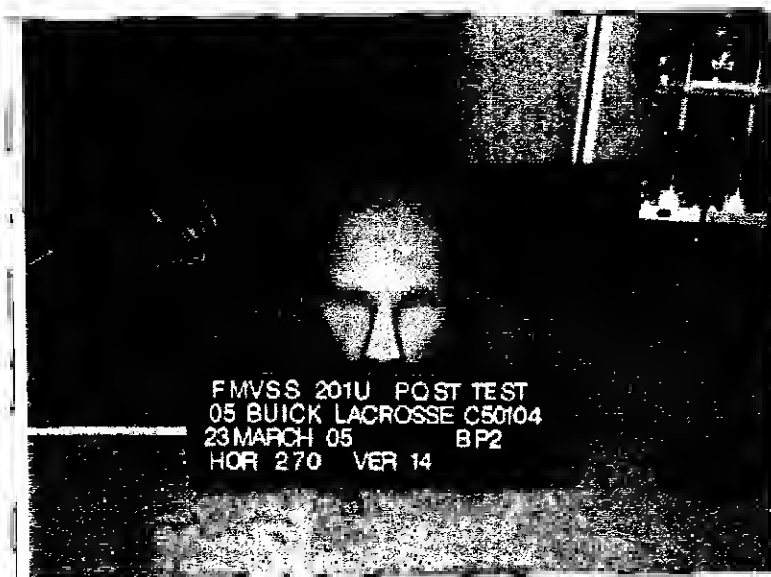
POST-IMPACT BP2 HEADFORM

Free Motion HIC	933.9
HIC(d)	871.0
Impact Velocity (kph)	23.83
HIC T1 (msec)	1.9
HIC T2 (msec)	7.4

Note: BP2 target location – Seat belt anchorage

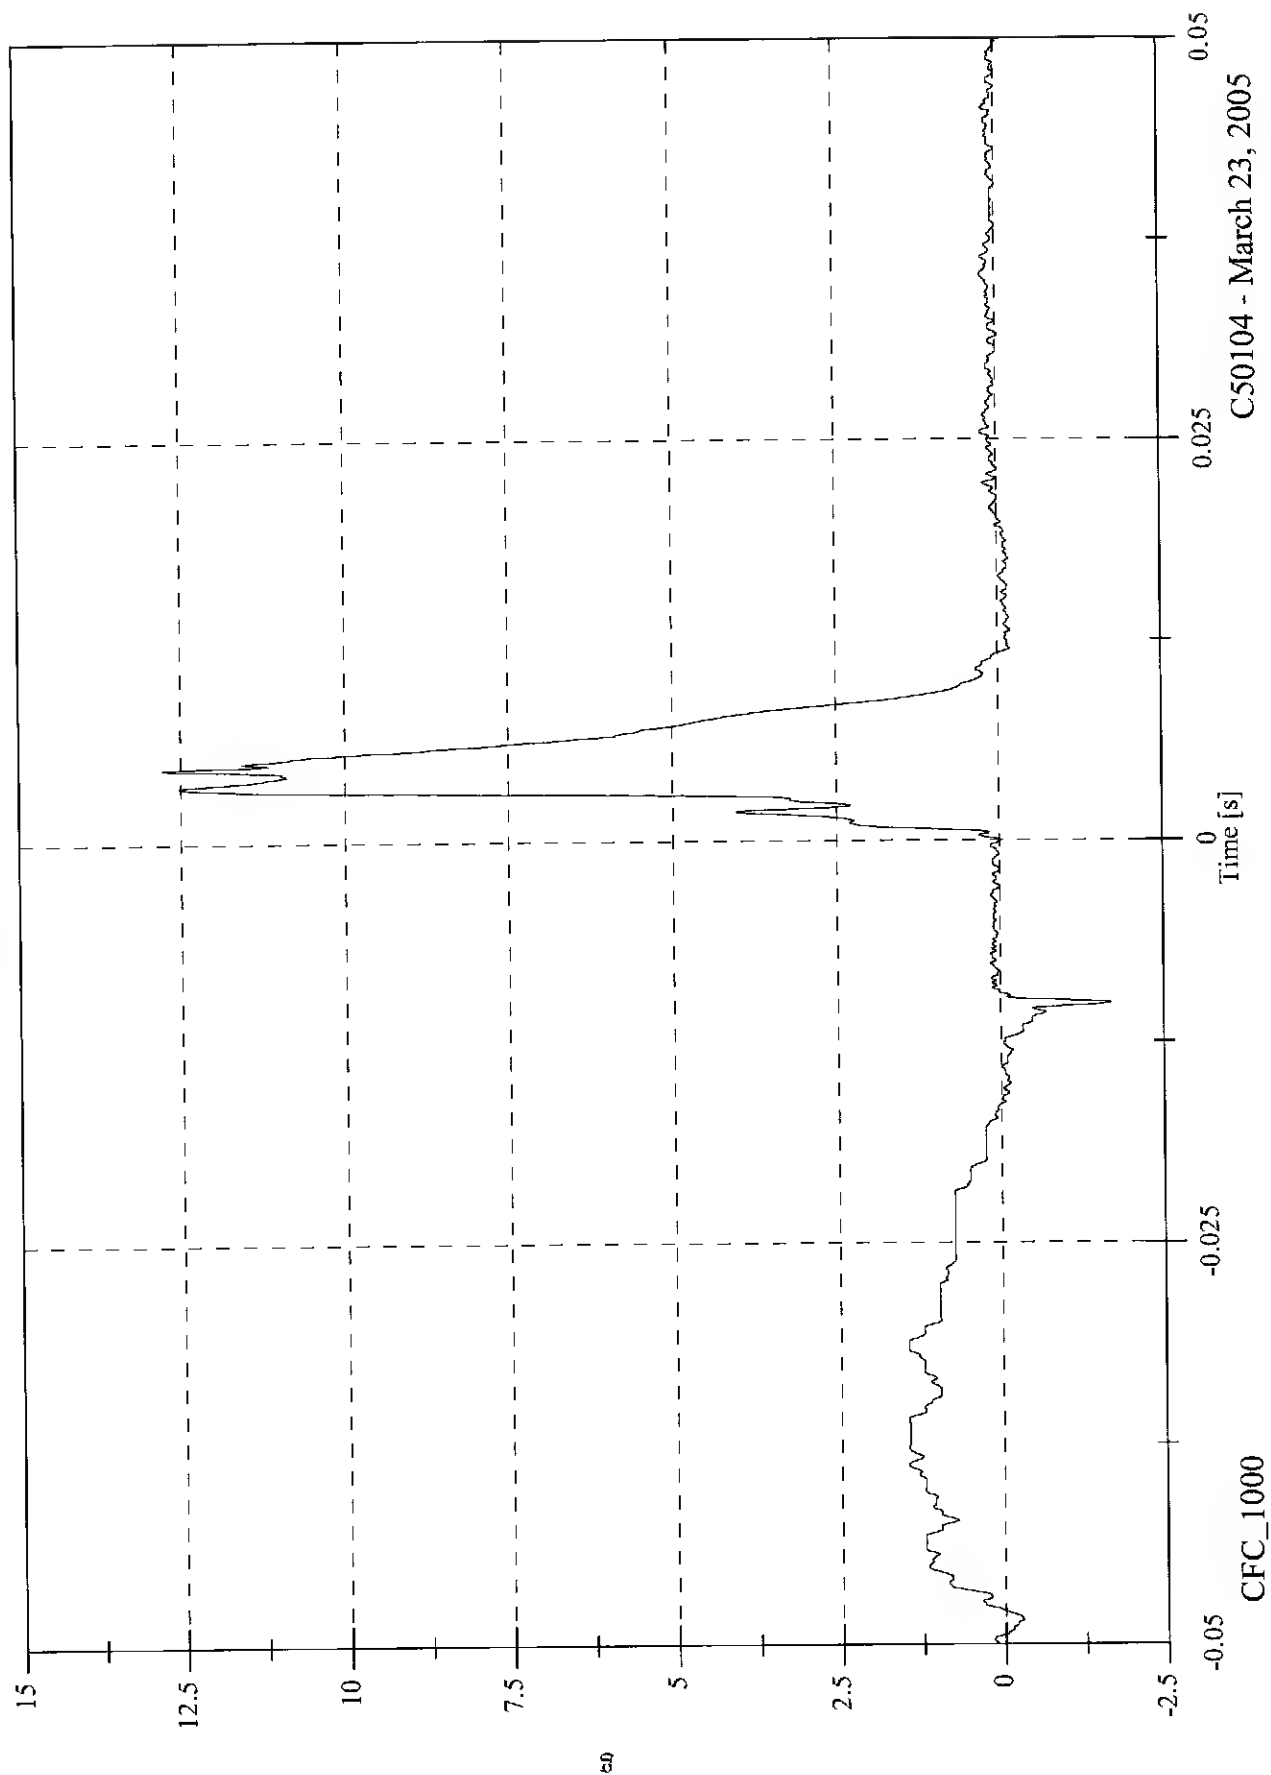
FMVSS 201U IMPACT TEST - 2005 Buick Lacrosse
Headform Y Acceleration

Max: 12.8 [g] at 0.005 [s]
Min: -1.7 [g] at -0.010 [s]

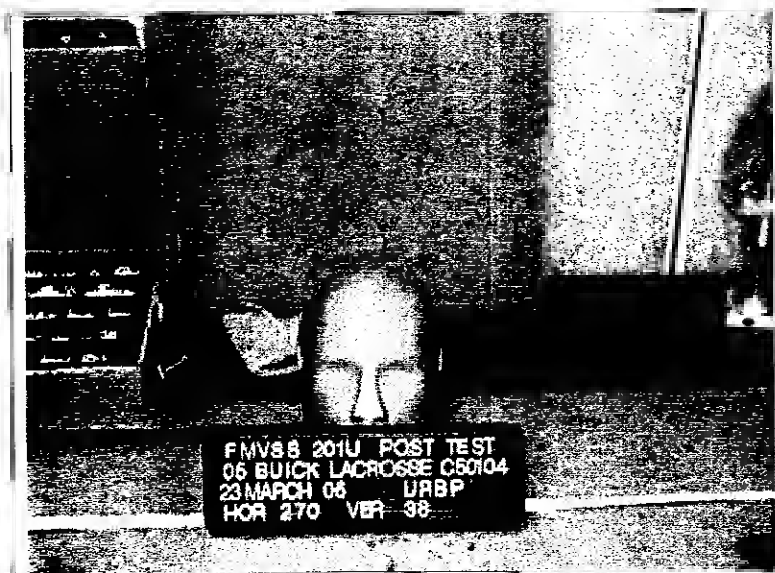
POST-IMPACT URBP HEADFORM

Free Motion HIC	t233.1
HIC(d)	1096.7
Impact Velocity (kph)	23.6
HIC T1 (msec)	3.1
HIC T2 (msec)	7.7

The selected impact areas on the test vehicle appeared to comply with the performance requirements of FMVSS 201 with the exception of URBP impact area.

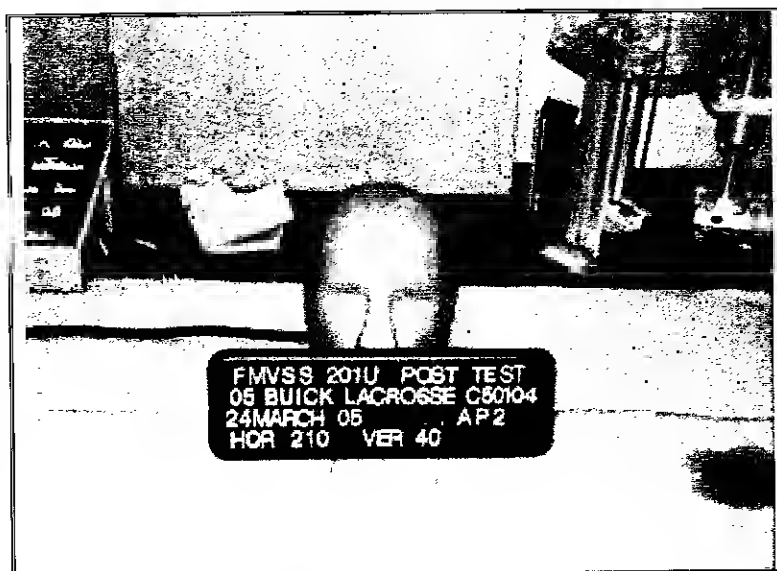
POST-IMPACT AP2 HEADFORM

Free Motion HIC	800.1
HIC(d)	770.1
Impact Velocity (kph)	23.72
HIC T1 (msec)	4.9
HIC T2 (msec)	8.1

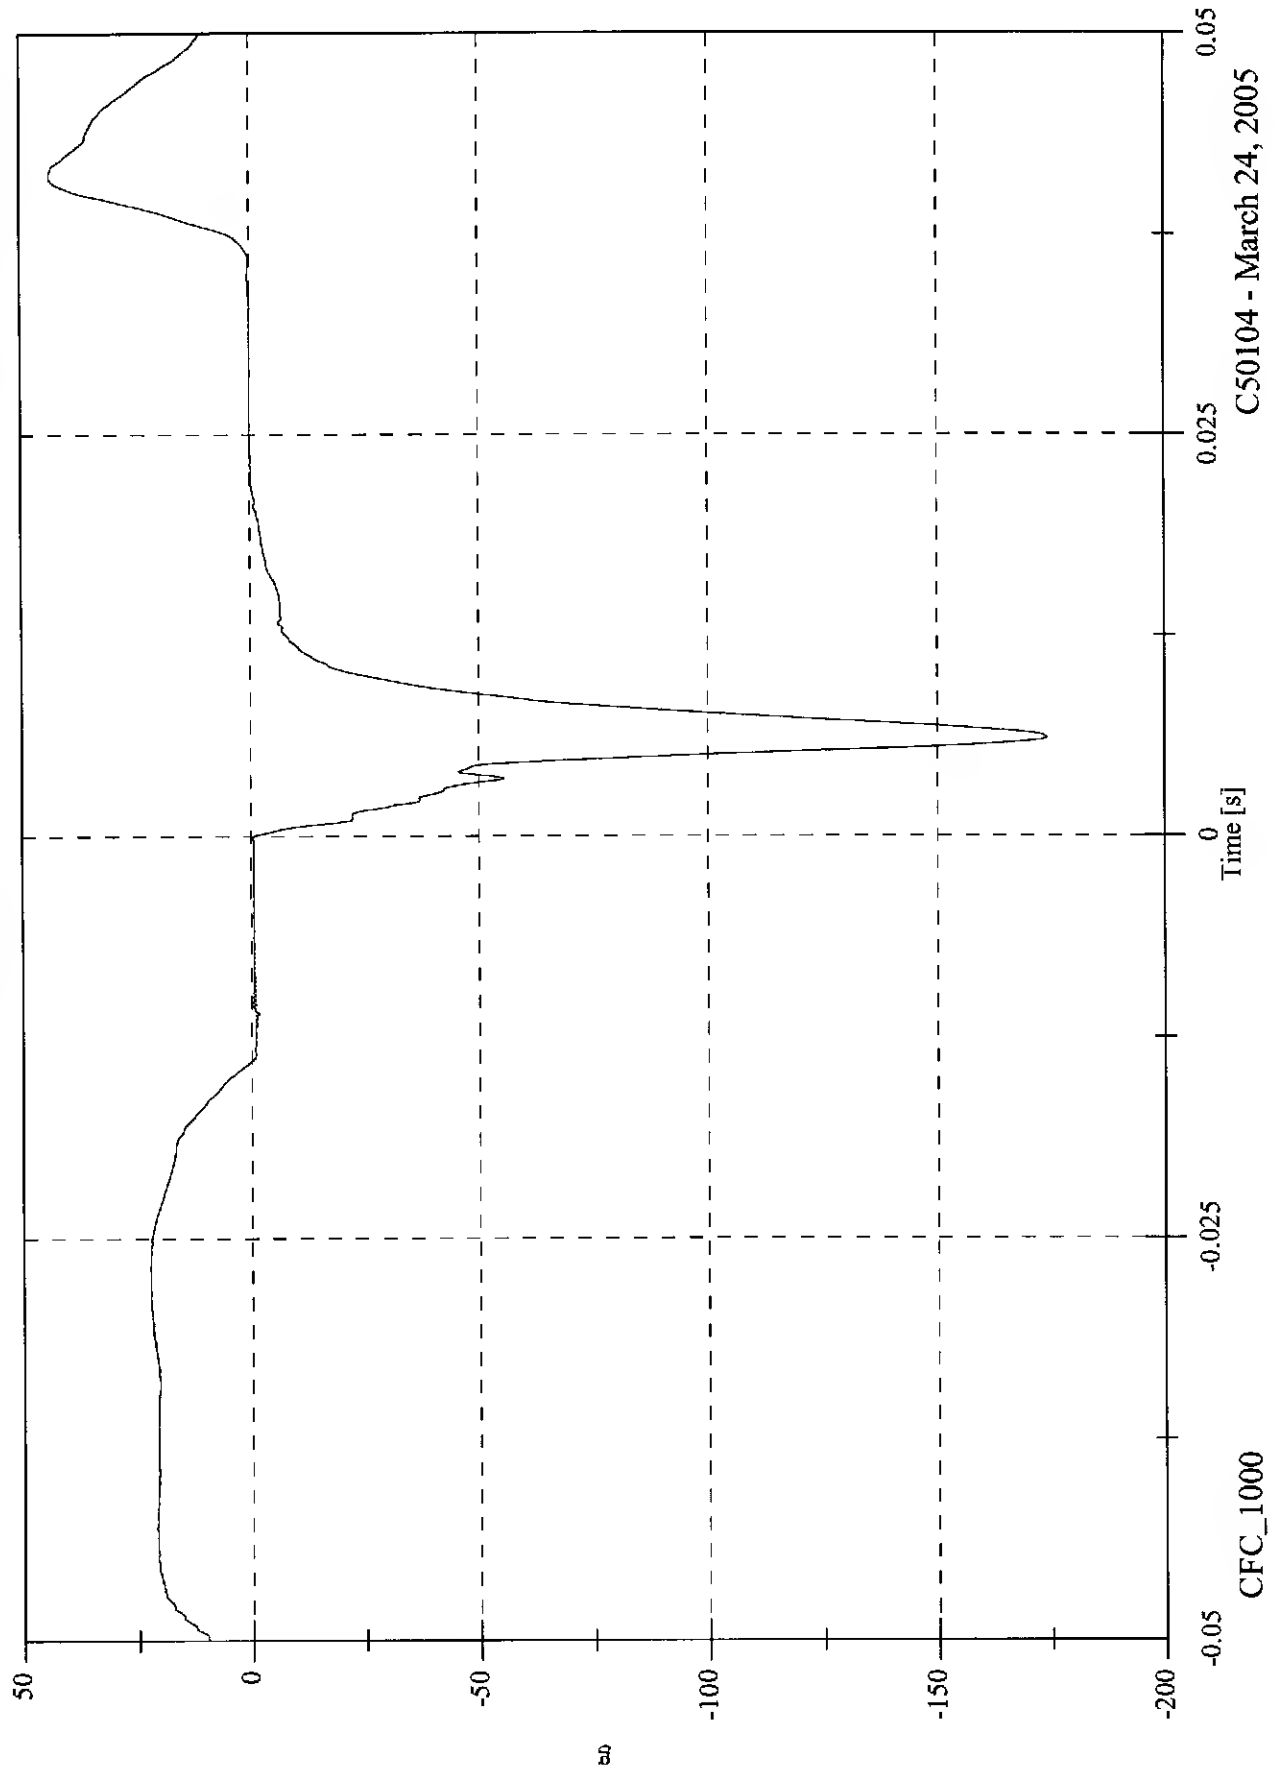
Max: 43.5 [g] at 0.041 [s]

Min: -174.1 [g] at 0.006 [s]

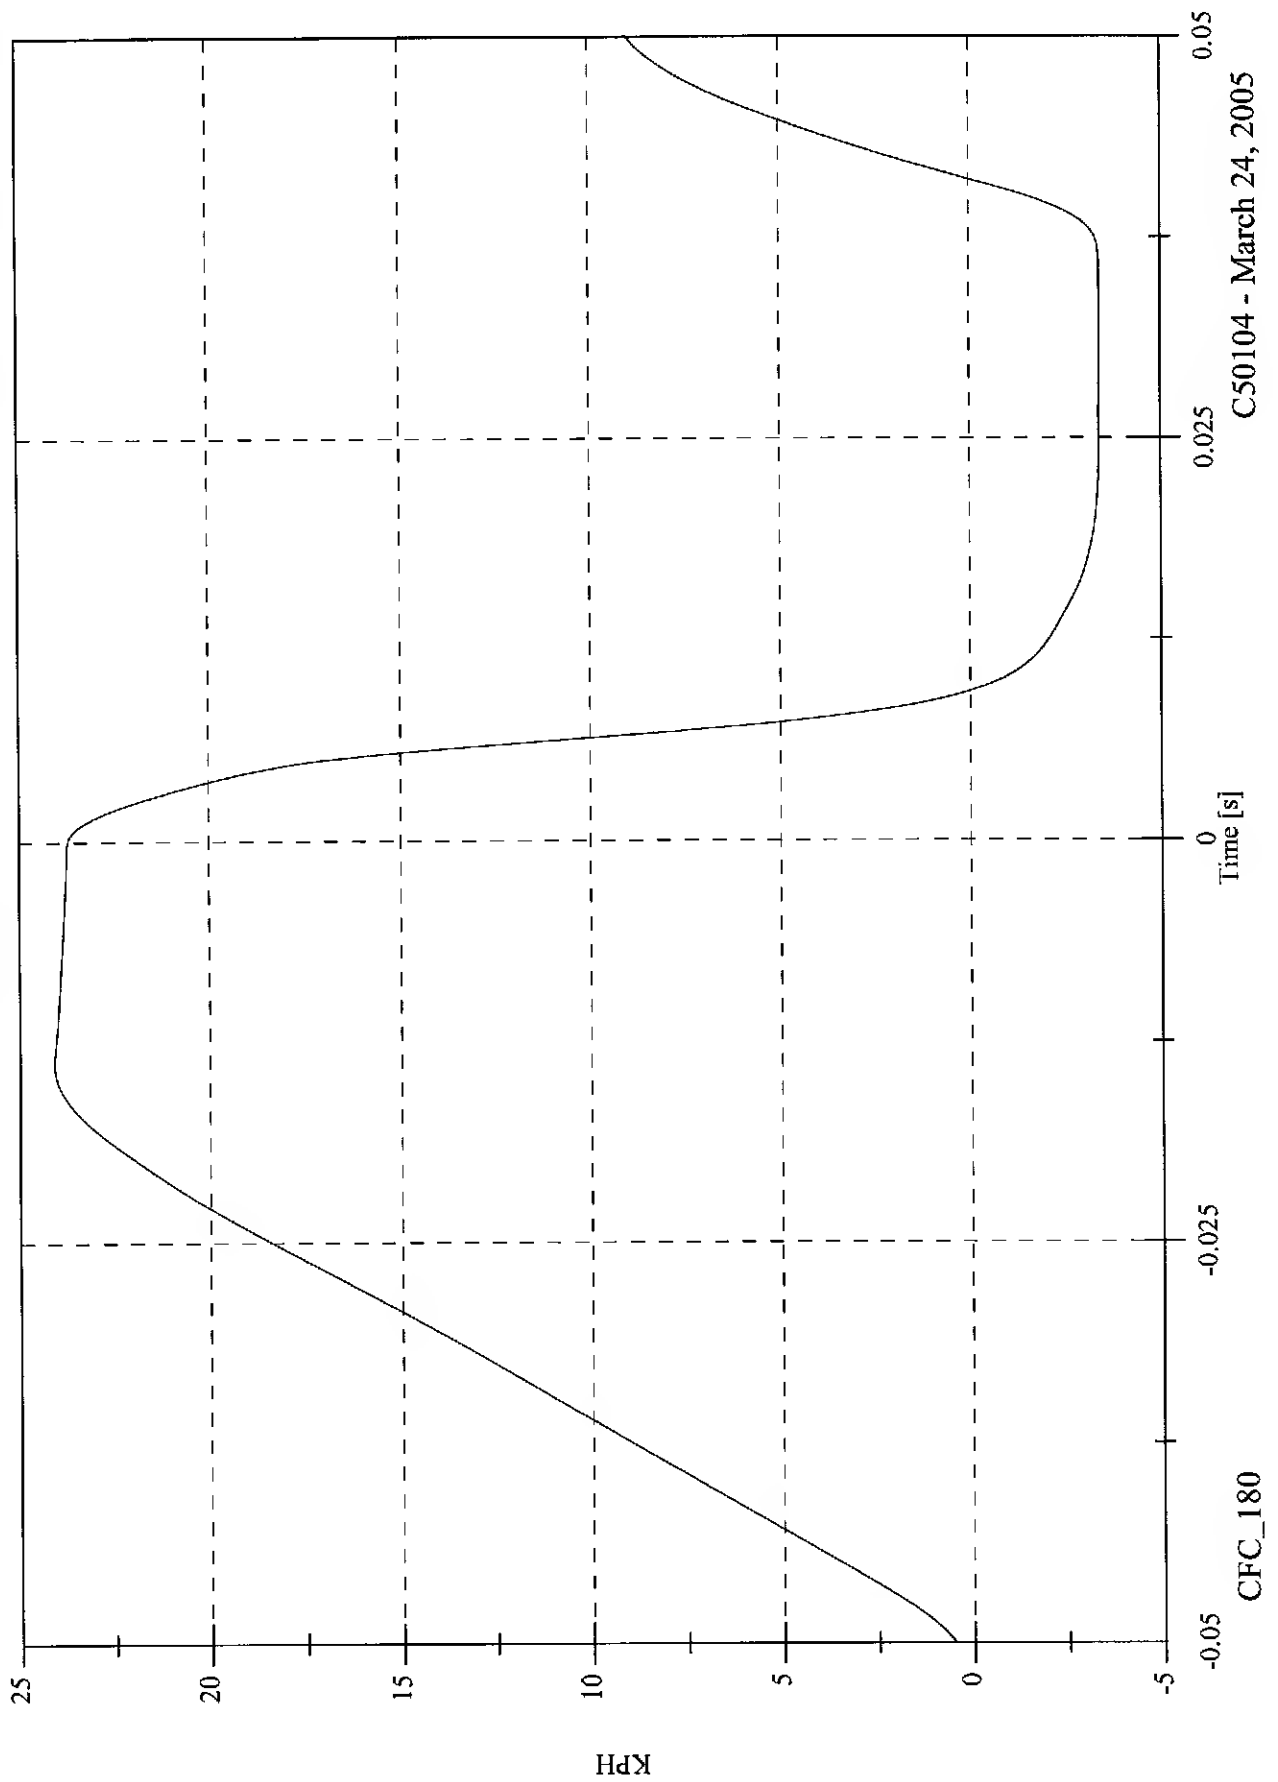
FMVSS 201U IMPACT TEST - 2005 Buick Lacrosse
Headform Velocity
Max: 24.1 [KPH] at -0.014 [s]
Min: -3.4 [KPH] at 0.034 [s]

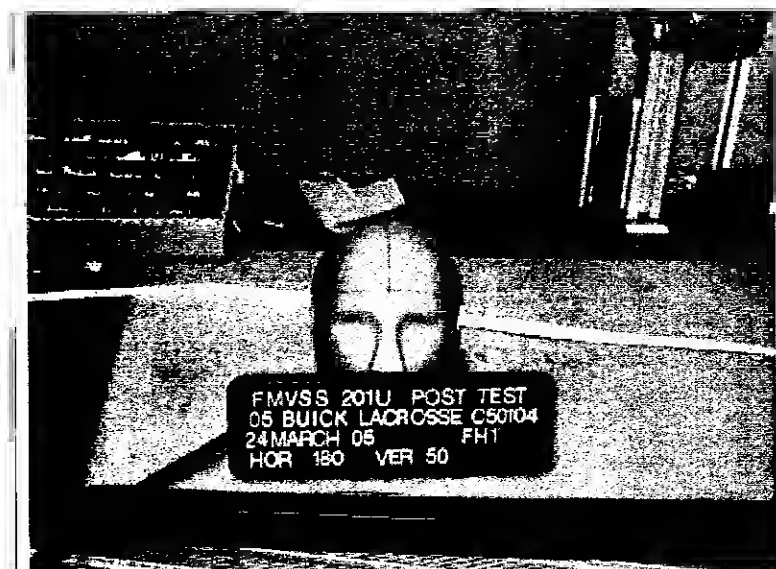
POST-IMPACT FH1 HEADFORM

Free Motion HIC	570.7
HIC(d)	597.0
Impact Velocity (kph)	23.74
HIC T1 (msec)	2.8
HIC T2 (msec)	6.6

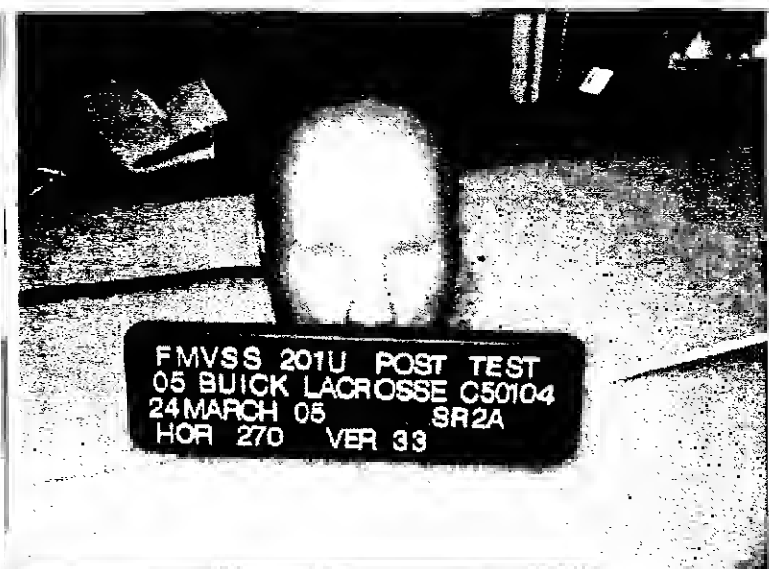
POST-IMPACT SR2A HEADFORM

Free Motion HIC	820.3
HIC(d)	785.3
Impact Velocity (kph)	23.48
HIC T1 (msec)	2.0
HIC T2 (msec)	8.2

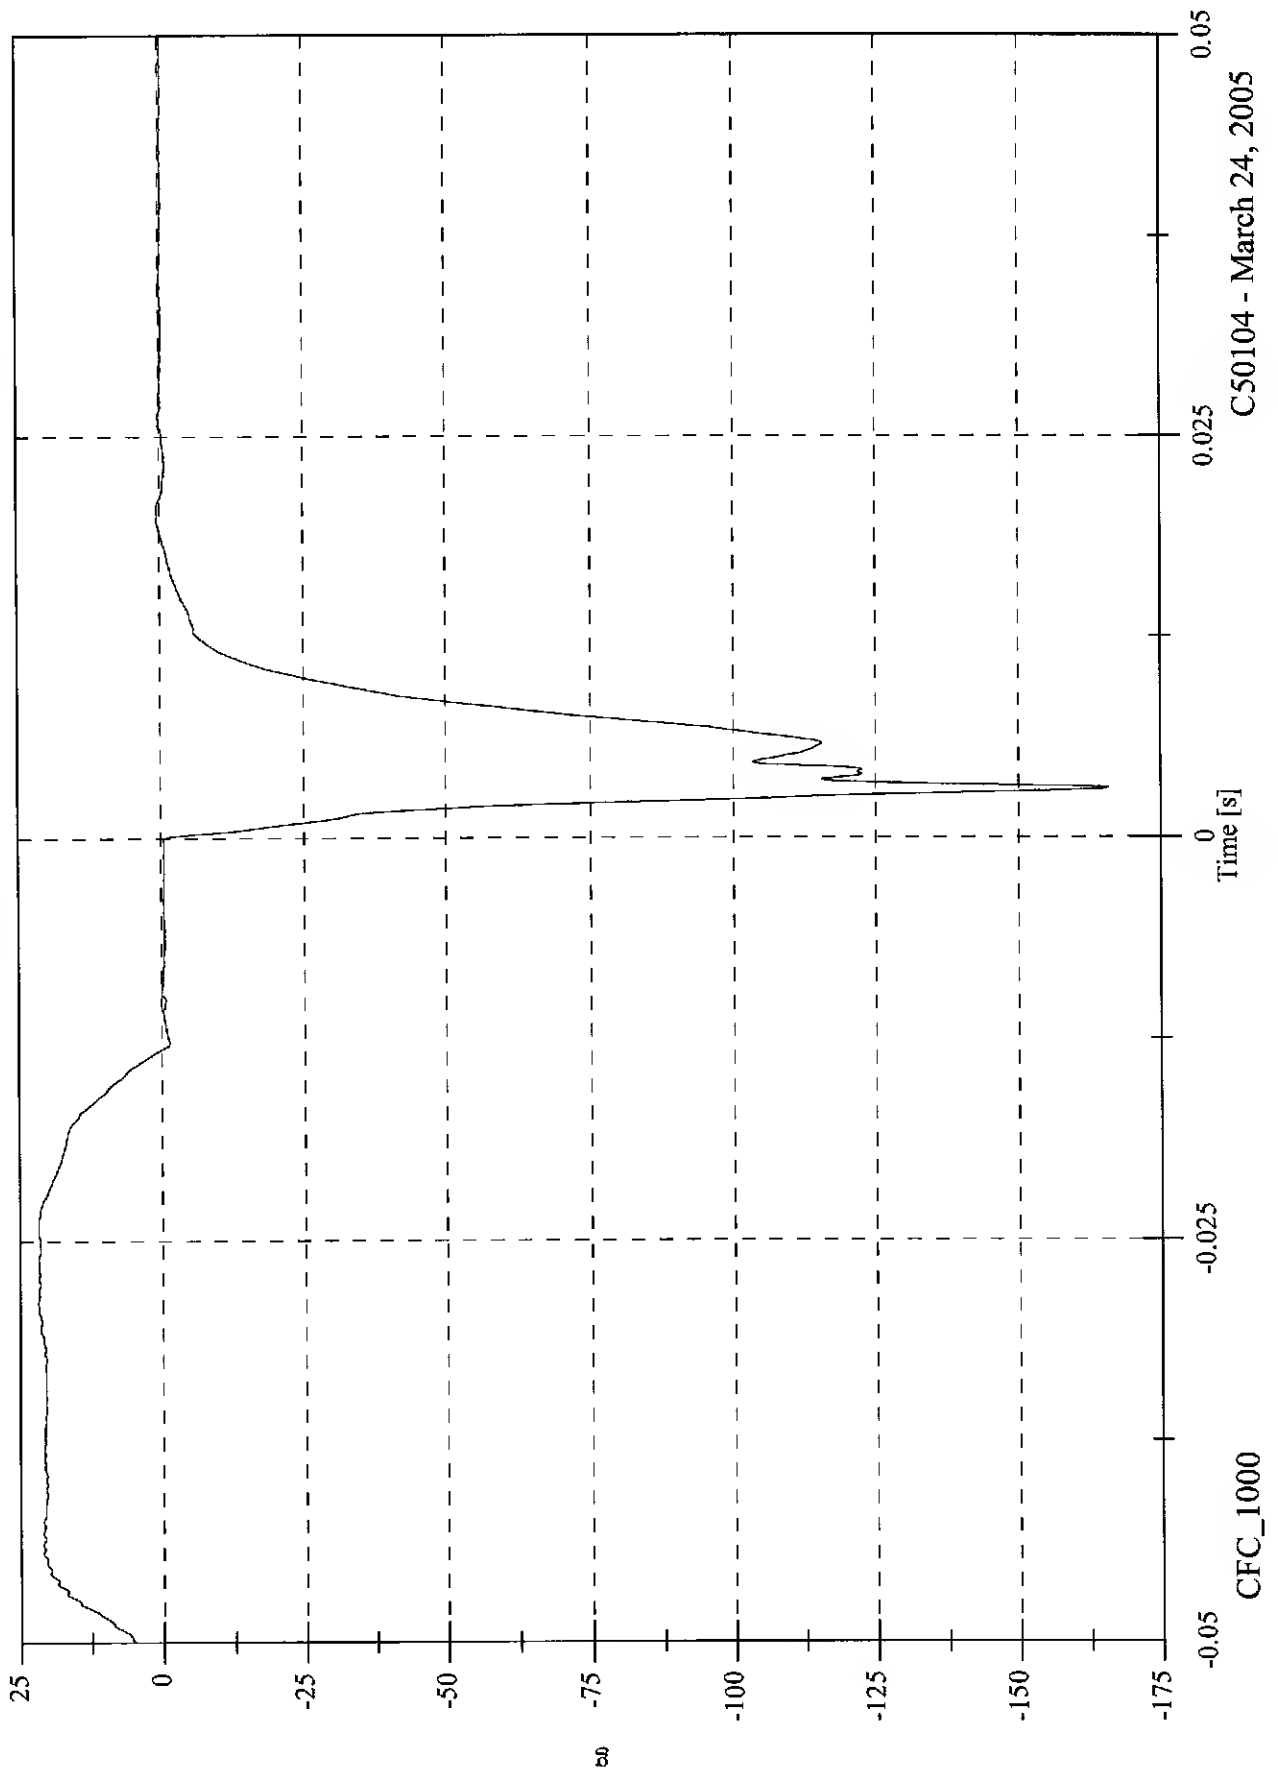
Max: 21.8 [g] at -0.029 [s]
Min: -165.9 [g] at 0.003 [s]
